5 "RED FLAGS" FOR HOME BUYERS

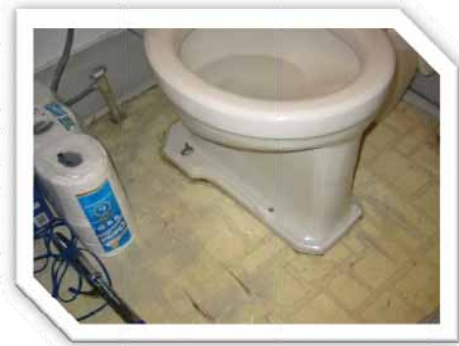
#2- STAINS AROUND THE TOILET BASES - Leaking toilet bases are very common in residential structures. When toilets are installed, they cannot be over tightened or it can fracture the toilet base. Nobody ever warns the owners to re-tighten the toilet base after a month of use. As a result, the toilet can be easily shifted and break a gap in the wax ring seal. What's a "wax ring seal" you ask? Well, it's the part that your toilet sits on and if it is loose, sewage water can leak around the toilet base and it allows water to pass through to the subfloor and cause damage, mold, and rot. Pretty gross, but unfortunately, pretty common. I recommend that buyers look closely around the toilet base for signs of subfloor swelling or flooring discoloration. As a water entry expert, I use a non-invasive moisture meter around the base of every toilet to identify leaking conditions that have not yet become visible to the naked eye (or that have been "staged" to cover up any potential signs).

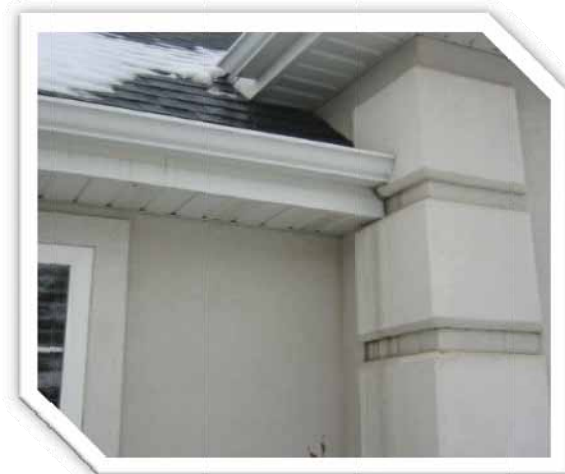
#3- STAINS ON THE OUTSIDE WALLS OF THE HOME - Water drip stains and cracks on the exterior of the home are often visible signs of water entry and unseen damage. I recommend that home buyers walk around the outside of their prospective house during the daylight hours and look for water drip staining. This is most visible on stucco and brick exteriors, but it is also visible on vinyl, wood, and composite-sided homes. It is usually related to multi-level roofs that terminate against vertical walls, and below chimney-to-roof joints. Please visit www.Kickout.info to see the damages related to missing roof flashings called the kickout flashing.

#3- STAINS ON THE OUTSIDE WALLS - continued – Kickout flashings were commonly omitted on most Utah homes up until about 2 years ago. Look closely for any and all stains and cracks and then ask the seller about any past exterior cracks, leaks, or repairs. Identifying the full extent of damage goes beyond the scope of a normal home inspection and requires a water entry and stucco expert like myself. This specialized inspection needs to be performed on homes where you can visibly see these signs of water entry to determine the scope of the damage so that it can be dealt with before you buy the home.

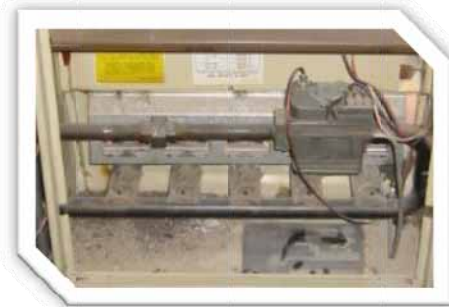
#4- FILTHY FURNACE - This may sound odd, but I recommend to prospective buyers that they remove the

covers on the furnace and see what condition the unit is in on the inside. If there are cobwebs, dust, soot or major rusting, then perhaps the buyer can add the repair/replacement of the furnace on the list of contingencies in the initial real estate purchase contract. Furnaces can range anywhere from \$1,200 to \$4,000 plus installation, and therefore home

buyers need to do everything that they can to ensure that they are protecting themselves from buying a home with a furnace unit that is ready to fail.

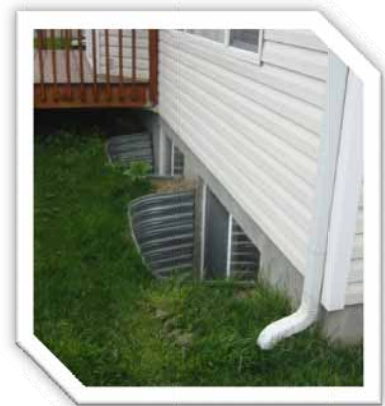
#5- POOR EXTERIOR DRAINAGE - Walk around the exterior of

the home while maintaining a distance of about 10 feet away from the foundation. Look at the earth between you and the foundation. Ideally the earth at the foundation should be about 6" higher (or more) than where you are standing. This promotes surface water drainage away from the foundation. Unfortunately, about 95% of the homes I inspect have areas that are either level or much lower and surface water is drawn towards the foundation. The collecting water will then search for hairline cracks in the foundation and draw water inside the home. This results in damage, mold, rot and is also a big attractor for subterranean termites. This condition can be easily corrected when it is identified, yet most Utah homeowners are oblivious to the negative grading issue.
