RADON REPORT

2221 South 400 East - Heber City, UT

CLIENT'S NAME: Mary Argyle DATE OF INSPECTION: 11/07/2023 **START TIME:** 9:00 AM INSPECTION #: 110723A

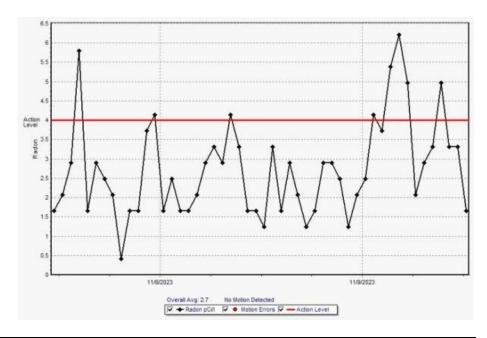
GRAPH:

RESULTS: The action level established by the US EPA and Surgeon General is 4 pCi/l. Results under the action level of 4 pCi/l are still considered a risk. Final test results averaging over 4 pCi/l are considered a risk that should be mitigated. Excessive radon levels is an indoor air quality issue related to cancer that can be improved with the addition of a radon mitigation system.

OVERALL AVERAGE pCi/I: 2.7 pCi/l. EPA AVERAGE pCi/I: 2.7 pCi/l.

RECOMMENDATIONS: UNDER 4 pCi/l - The USEPA states that "EPA Average" results in this range

(less than 4 pCi/l) are below the accepted risk threshold, but still pose a risk.

No further actions are recommended at this time.
