A Close Look at Stucco

Problems with stucco persist, yet properly installed standard details are still the cure

by Dennis McCoy

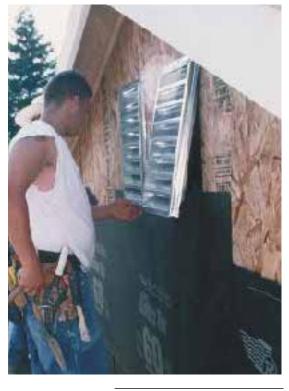
Flashing details frequently involve the interaction of two trades. Here, for example, the stucco crew members responsible for installing the building paper had to remove and reinsert a gable vent installed by the framers so that they could run building paper under the vent flange.

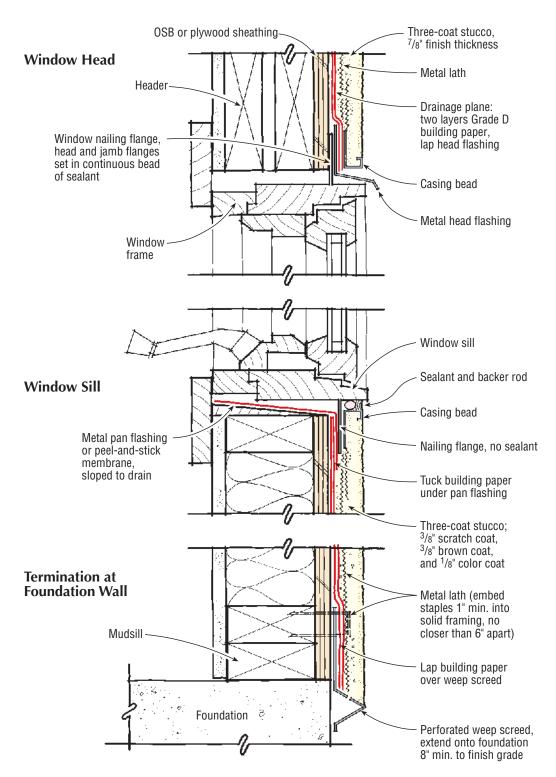
Stucco Drainage Details: Three Systems, One Principle

Traditional Three-Coat Stucco

Three-coat stucco relies on traditional details to keep water flowing down the wall and away from the building. Openings, transitions, and terminations are flashed to let water escape, while building paper, lapped over the flashings, keeps water away from the wood.

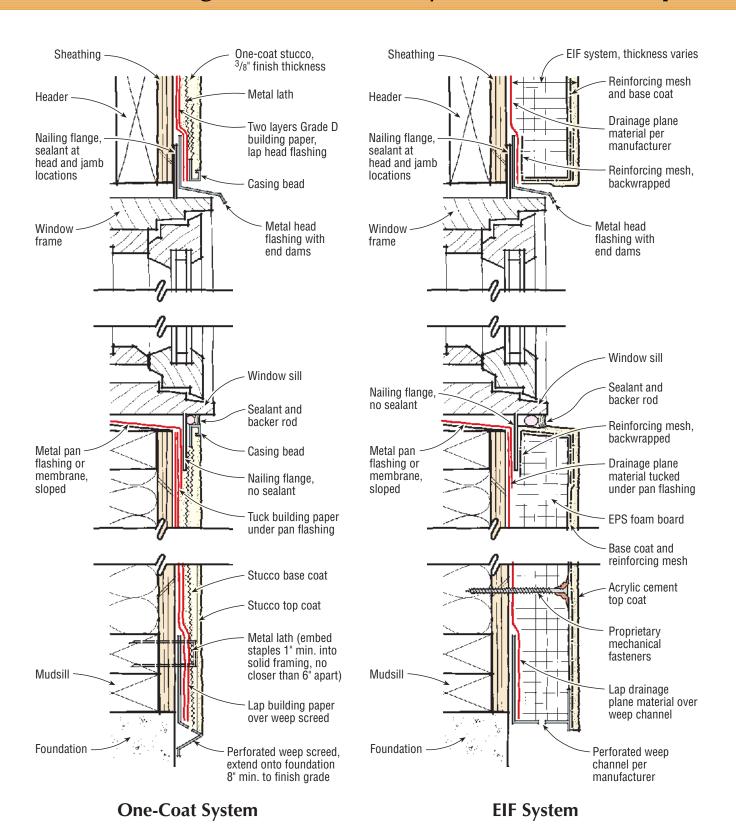
Stucco Drainage Details: Three Systems, One Principle

EIFS and modified thin-coat systems, while they have different substrates, rely on the same water-management details as traditional three-coat stucco.

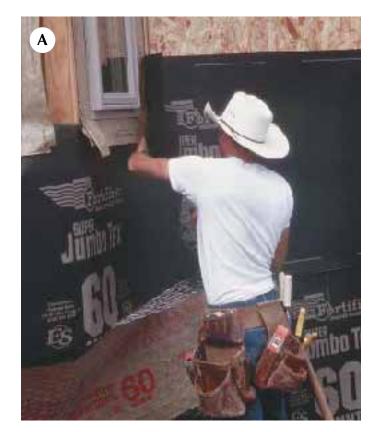
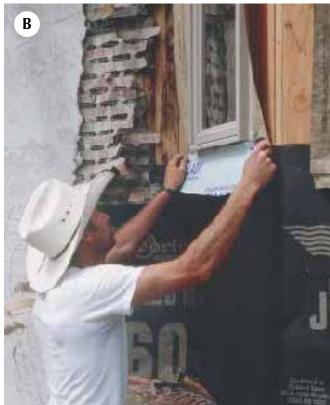
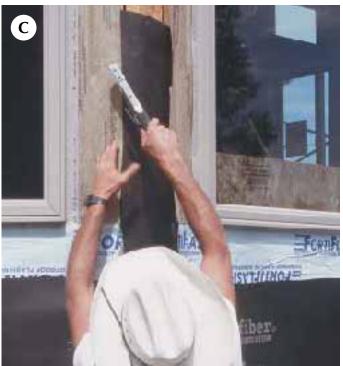
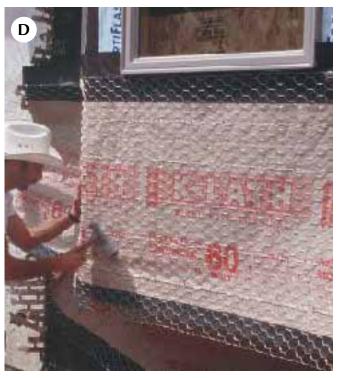
Integrating building papers with window flashings can be a challenge on site. In California, where this crew works, stucco contractors aren't typically licensed to install windows, so the paper crew must work with the existing flashing. Here, the window crew left the window perimeter protected by strips of flashing, with side strips lapped over the bottom strip and the head strip lapped over the side strips and the window flange. The paper installer lifts the bottom flap and runs paper under it (A), then seals the flashing to the paper with adhesive membrane (B). Next, he lays paper under the side window flashings and staples the flashing down before applying membrane to this joint as well (C). Paper-backed lath then butts directly to the window flange (D), but water that gets behind the stucco at the window sill and jamb will be handled by the membrane, the flashing, and the first layer of paper.

Coordination on site can make or break this installation. Where window flashings dump under the paper, it's probably because the window installers put the flashings in before the stucco installers came to paper the building. The paper has to go on first, then the flashings, then the window, and finally the lath. Each trade has to wait for the one before, or you have to figure out a way to leave the flashings hanging so they can be integrated into the building paper later.

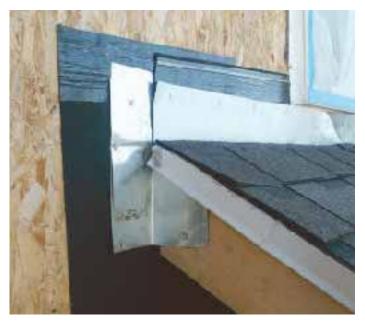
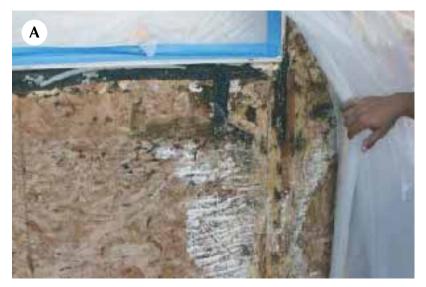
Here, the window installers and the roofers have not coordinated their work. Roof flashing will effectively catch water coming off the main wall if stucco papers are applied to lap over it. However, the window flange dumps behind the roof flashing instead of onto it. The author's crew removed this window and reflashed the opening before reinstalling the window.

Another typical case is shown in the photo on page 7. Here, the window flange is likely to dump behind the roof flashings if someone is not careful. This situation was found on one of my company's retrofit jobs. My crew removed the window, papered the wall with papers lapping on top of the roof flashing, flashed the window opening so the flashing dumps on top

of the paper, then reinstalled the window with flanges outboard of the papers and flashings so that water always moves away from the building as it heads downhill.

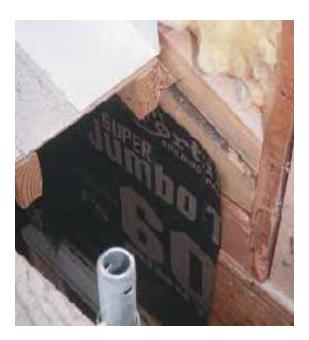
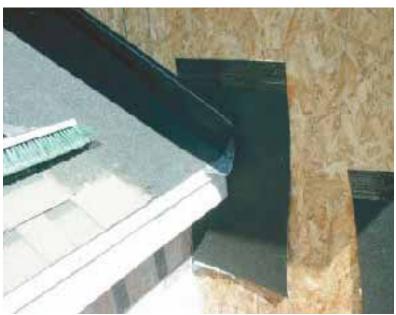
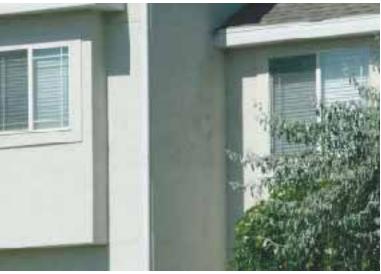
Roof-to-wall intersections create particular problems. At top left, this bad detail held up the work: The rafter placed tight to the building wall does not allow paper to slip behind it, and the flashing left by the roofers will direct water behind the stucco and into the wall if used as configured. The photo above shows a water diverter (kick flashing) installed by the author's crew in a retrofit job: This design will lead water out away from the wall and dump it off the roof's drip-edge rather than into the wall. Papers installed on the main wall can readily integrate with the membrane and flashing between roof and wall at the rafter tail. At left, a wall-and-roof intersection built without the correct flashing detail shows discoloration and staining after a few years in service; the author typically finds significant rot in buildings with this detail, even though the wall surfaces may show only minor traces of trouble.

Roof-to-wall joints. The most damaging leakage we see in our work takes place where roofs intersect walls, either because a one-story roof meets a two-story wall, or because a chimney chase meets the roof. It takes work to keep the roofers and the stucco applicators coordinated so that their work

Every roof needs some kind of L-shaped flashing where the roof abuts the wall. Metal step flashing, or as we call it, "step shingles," is typical for asphalt or shake roofs; tile roofs usually get a continuous piece of metal J flashing.

Where stucco is new in the market, the appropriate metal step shingles for stucco application can be hard to find. Folded flashings intended for use with asphalt shingles and vinyl siding are too small for stucco. In Salt Lake City, the typical step shingles on the shelf are 8 inches long, with a 2inch leg for the wall and a 4-inch leg for the roof. Stucco requires a 2-inch reveal between the bottom termination of the stucco and the roof surface (many EIF systems need a 3-inch reveal), and a 2-inch lap of the building paper over the metal, so step flashings must have at least a 4-inch vertical leg.

Since you can't be sure of finding the right size metal flashings in all markets, I always use rubberized asphalt sheet material like Ice and Water Shield as a backup.

However, the flashings are still important, particularly the water diverter or "kickout flashing" at the bottom of the roof, which kicks roof runoff away from the wall system. Where this is not installed, water from the roof will overwhelm the stucco system and cause at least a visual problem, and commonly a major structural problem.
