<section-header>

10787 S. Lake Terrace Avenue - Daybreak, UT

CLIENT & INSPECTION INFORMATION

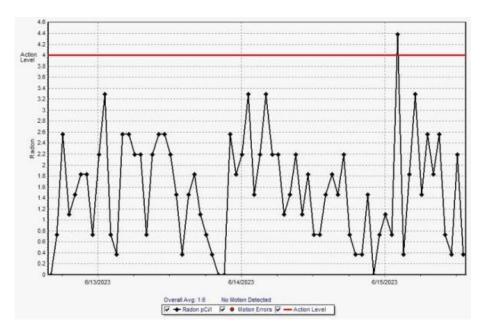
GRAPH:

RESULTS IN PCI/I:		
OVERALL AVERAGE pCi/I:	1.6 pCi/l.	
EPA AVERAGE pCi/I:	1.6 pCi/l.	
HOURLY READINGS:	Date: 06/12/2023	
	Time Counts Flags pCi/l	
	16:07 0.0	
	17:07 0.7	
	18:07 2.6	
	19:07 1.1	
	20:07 1.5	
	21:07 1.8	
	22:07 1.8	
	23:07 0.7	
	Date: 06/13/2023	
	Time Counts Flags pCi/l	
	00:07 2.2	
	01:07 3.3	
	02:07 0.7	
	03:07 0.4	
	04:07 2.6	
	05:07 2.6	
	06:07 2.2

11:07	2.6
12:07	2.2
13:07	1.5
14:07	0.4
15:07	1.5
16:07	1.8
17:07	1.1
18:07	0.7
19:07	0.4
20:07	0.0
21:07	0.0
22:07	2.6
23:07	1.8
Date:	06/14/2023
Time	Counts Flags
	pCi/l
00:07	2.2
01:07	3.3
02:07	1.5
03:07	2.2
04:07	3.3
04:07	2.2
06:07	2.2
07:07	1.1
08:07	1.5
09:07	2.2
10:07	1.1
11:07	1.8
12:07	0.7
13:07	0.7
14:07	1.5
15:07	1.8
16:07	1.5
	2.2
17:07	
18:07	0.7
19:07	0.4
20:07	0.4
21:07	1.5
22:07	0.0
23:07	0.7
Date:	06/15/2023
Time	Counts Flags
	pCi/l
00:07	1.1
01:07	0.7
02:07	4.4
	0.4
03:07	
04:07	1.8
05:07	3.3
06:07	1.5
07:07	2.6
07:07 08:07	
	2.6
08:07 09:07	2.6 1.8 2.6
08:07 09:07 10:07	2.6 1.8 2.6 0.7
08:07 09:07	2.6 1.8 2.6
